The Huia Tramline

Peter Hopcroft

With its three feet six inch gauge, substantial ballasting, well-made cuttings and avoidance of erratic curves, the line is totally different from the usual run of tramlines found on large civil engineering tasks.

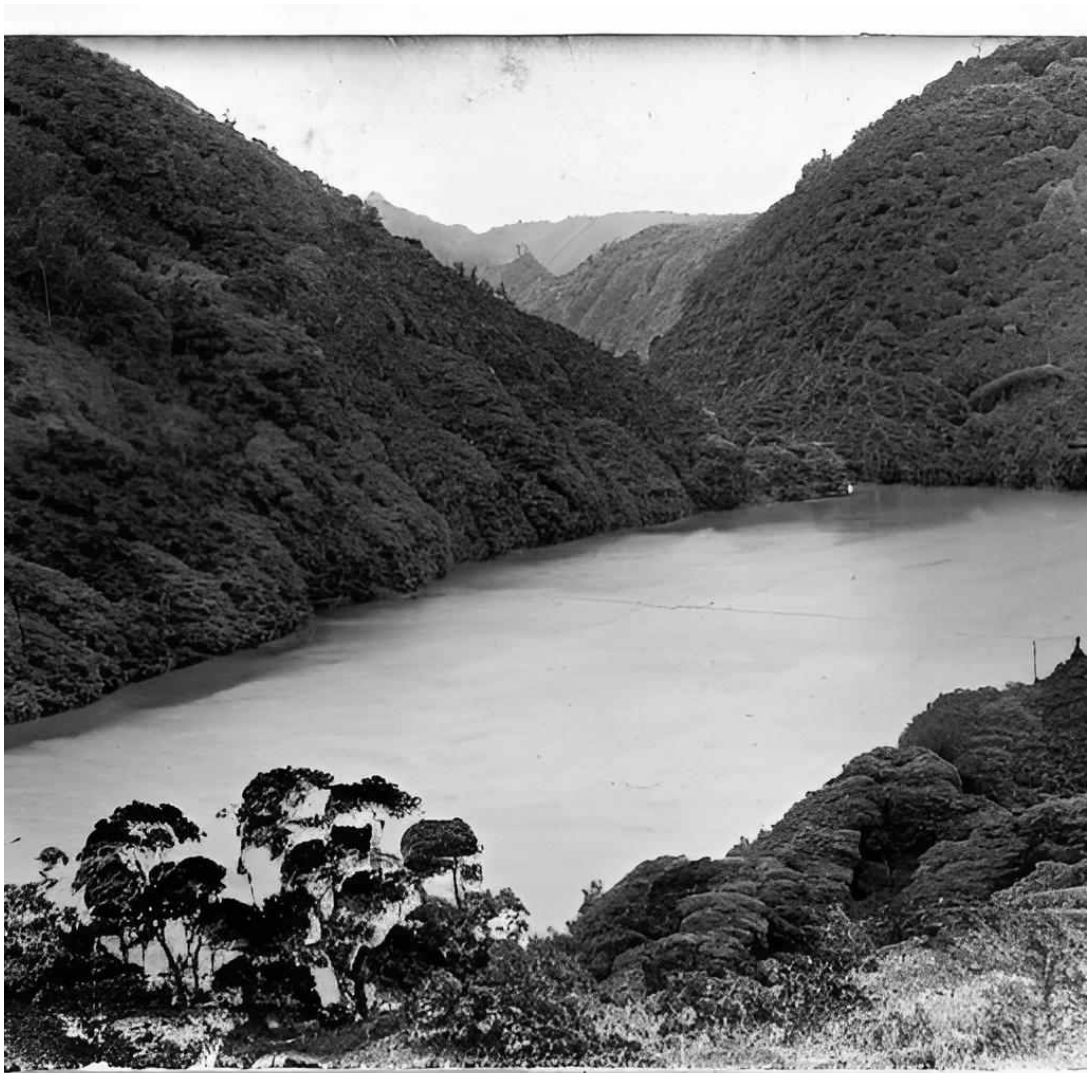
Huia dam. 1947. Bottom left is the tramline and Huia Stream. Top right is a flooded tramline cutting, just up from Castles Bridge.

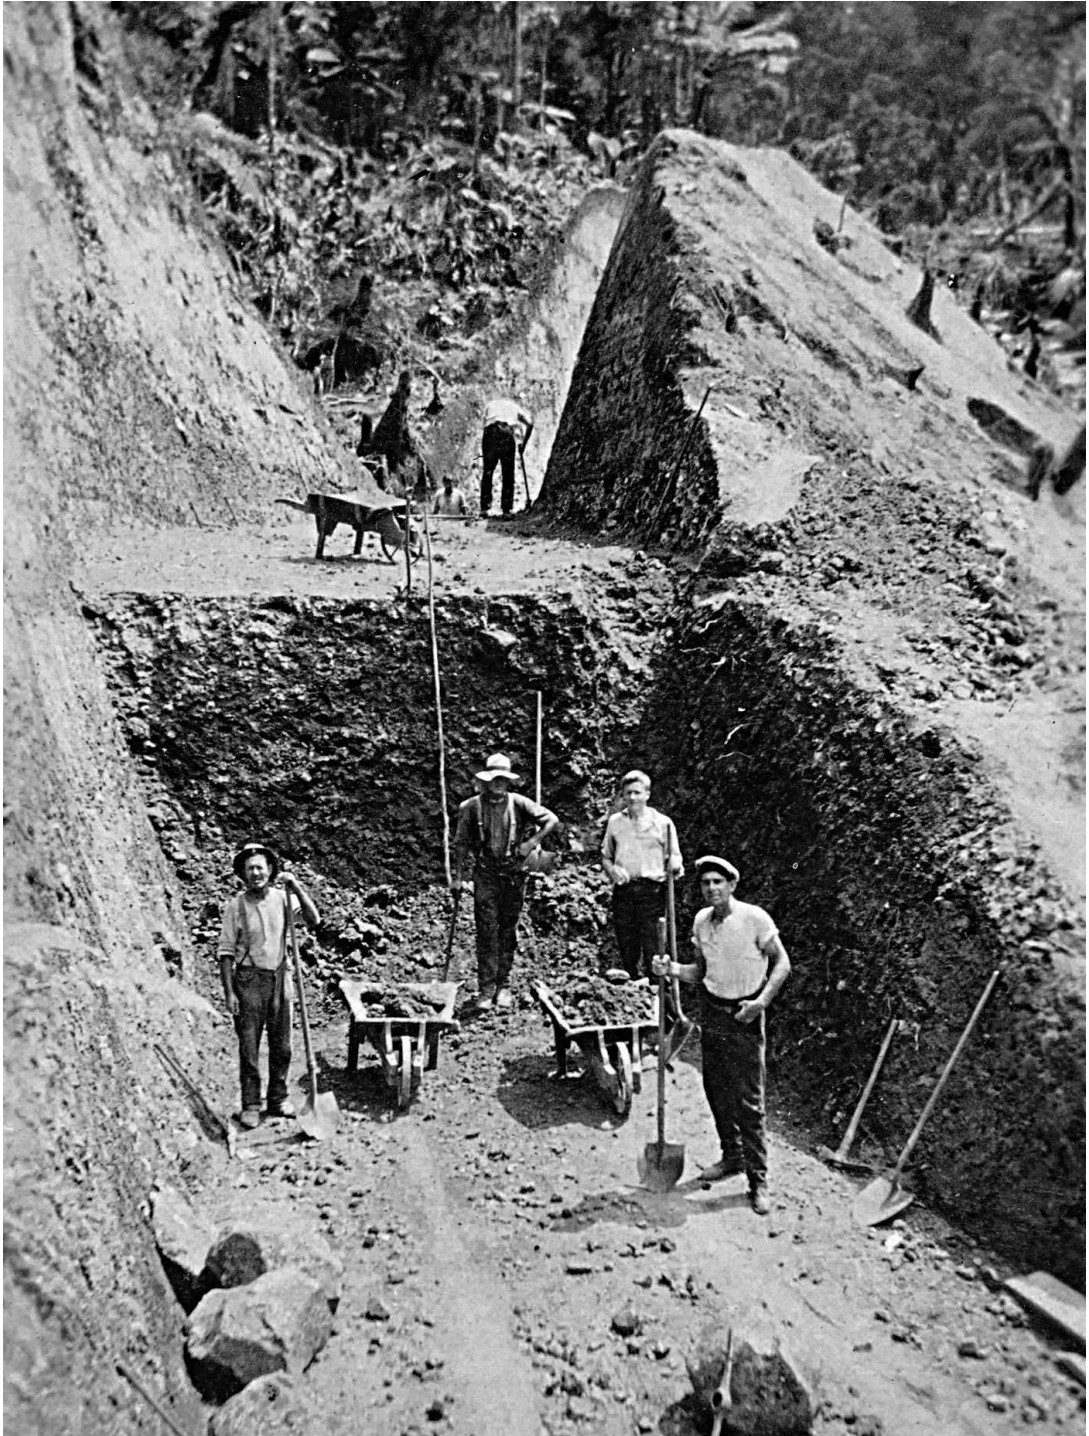
Workers digging one of the big cuttings just up the valley from Georges Creek. They would have

A cutting, where the track was below ground level. The workers carted the spoil away in wheelbarrows or in small railway wagons pushed by hand on temporary rails.

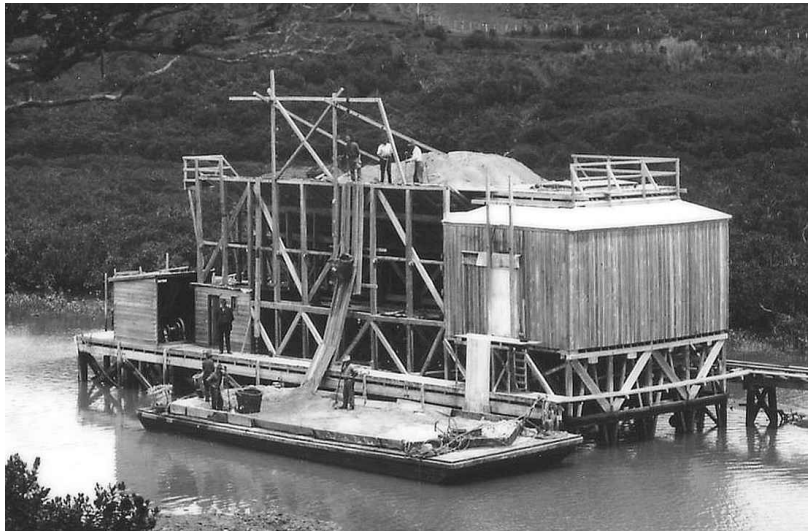
Workers unload sand from a hopper barge at Big Muddy Creek, for building the upper Nihotupu dam. About 1920. The shed with vertical boards stored bags of cement. The tramline to the Nihotupu dam runs off to the right.

There were two common types of barge on the Manukau harbour. A hopper barge had a large, open hold to carry loose material, like sand and cement bags. A pontoon barge had a flat top to carry supplies. A typical 1920s Auckland barge was about 6 metres wide. The ones for Huia would have been about 15 metres long.

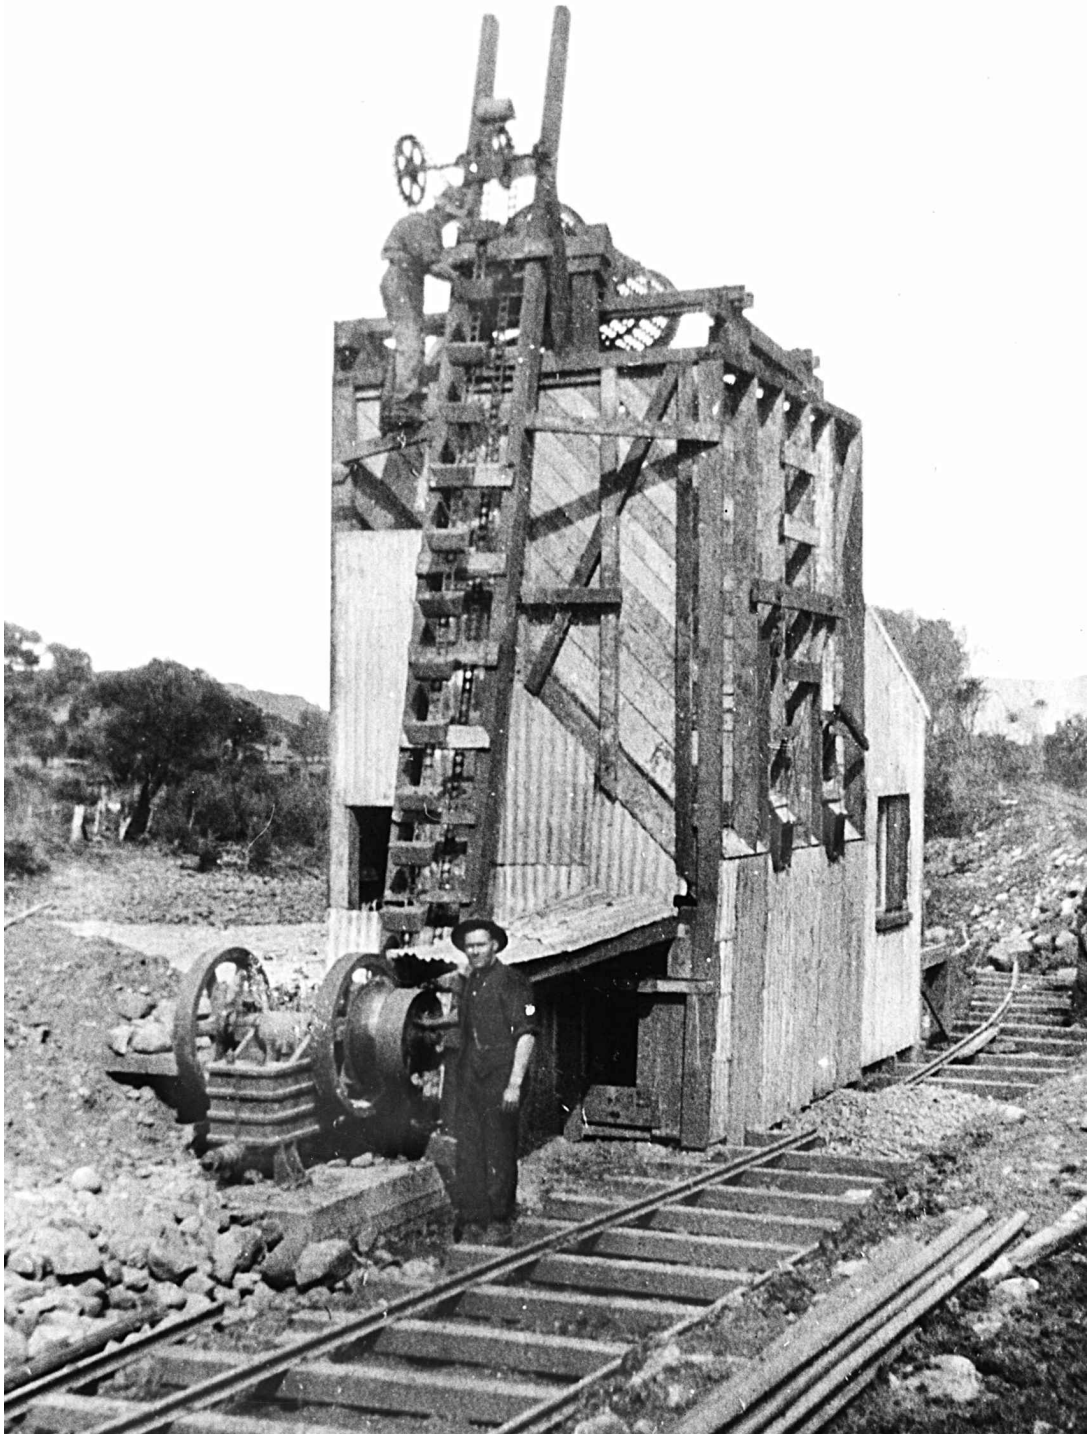
Huia Bay crusher, about 1925. The crusher, on the left, is driven by a belt from the kerosene engine under the hopper. The elevator lifts the crushed rock to the rotating cylindrical screen on top.

The dam workers' first job was to open up a small quarry about half a kilometre up the valley, and to build a crusher for its rock. The crusher's first job was to crush rock for concrete for the landing.

The crusher's main job was to crush ballast for the tramline. Ballast is the small rocks that support the track. The tramline had about half a cubic metre of ballast for every metre of track. The tramline to the dam was 6.6 kilometres long and built in 2 years. That's about 4.5 cubic metres, or 6 tonnes, a day. It also crushed rock for concrete for the dam foundations, and to form roads and paths.

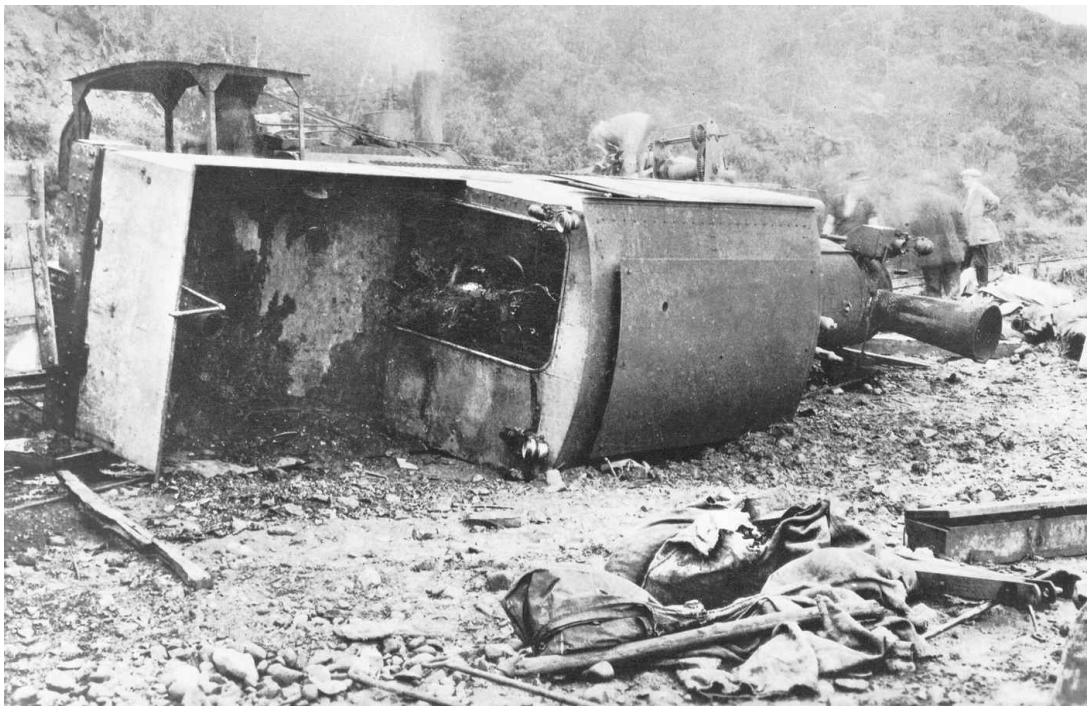
↓ A rare top view of a locomotive. The big fuel compartment is on the left.

The Price's fuel compartment was big, sized for wood. At Huia they burned coal, which needed much less space. Photos show passengers, adults and children, riding in the fuel compartment.

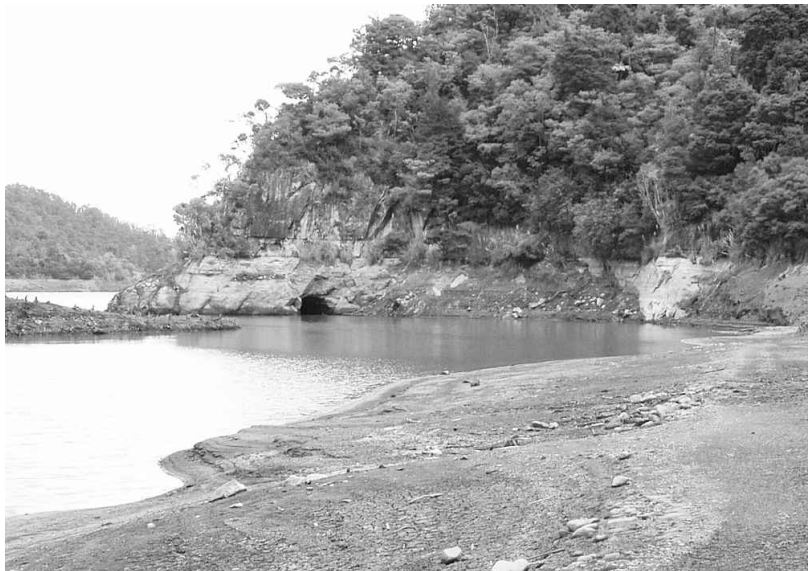
Looking down the valley to the tunnel, partly revealed when lower Huia reservoir was low in 2007. The line of stones in the right foreground was a low retaining wall along the side of the tramline.

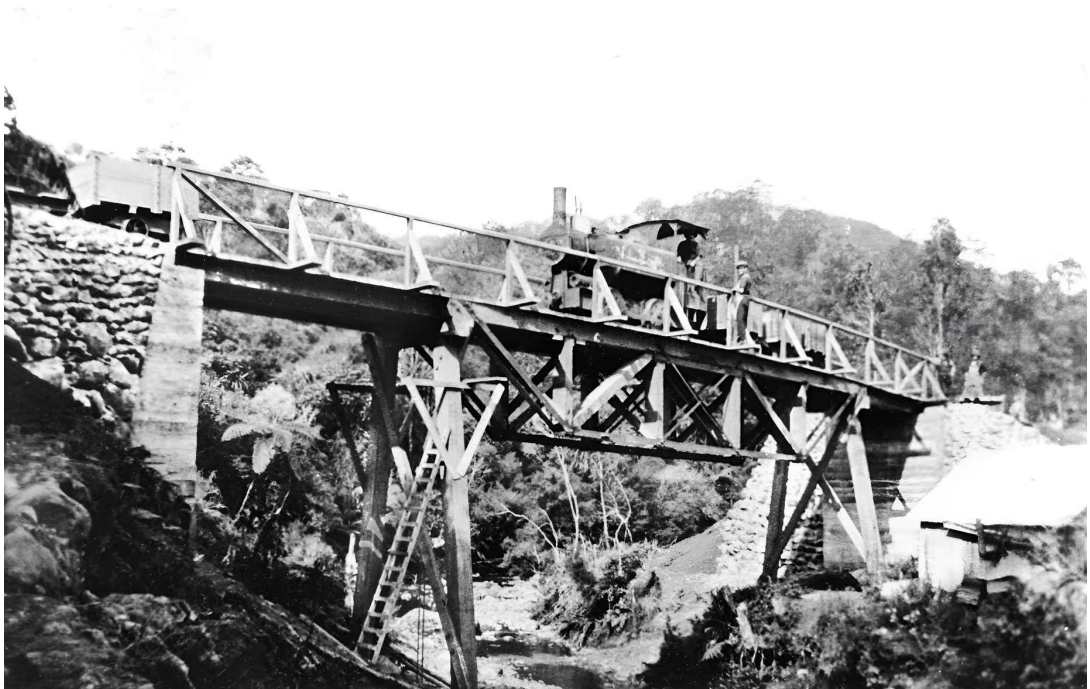
Like other bridges on the landing tramline, Georges Bridge had 2 vertical piers, which supported 3 horizontal beams. The middle beam was longer than the outer two. This enabled the pier foundations to be on the creek bank rather than in the creek.

The bridge's middle beam was too long to use single pieces of timber. Instead, it had 2 trusses, 1 hanging from each side of the bridge. A truss is an arrangement of horizontal, vertical and diagonal beams joined together. When a train crosses the bridge, the weight of the train compresses some of the beams and stretches others. A truss is much stronger than a solid beam of the same weight. The beams that were compressed were usually made of timber. Timber is cheap, easy to work and strong when compressed. The beams that were stretched could be made of timber or thin steel bars or rods. Steel is very strong when stretched. Georges Bridge is called a Howe truss bridge. Some of its beams are steel.

All-timber and timber-steel truss bridges were often built in New Zealand before the 1920s. Most truss bridges have the trusses above the deck, perhaps to keep them above the stream. Georges Bridge had the trusses hanging below the deck. This made it possible to fit diagonal braces between the trusses.

The parts for the bridge were bought up on the tramline and assembled flat on the ground at the south end of the bridge. First the piers were assembled, then winched down into the creek onto their foundations, raised to the vertical and held in place with beams between the bridge abutments and the tops of the piers. A winch and flying fox pulled the trusses across and into place. Fitting the trusses was a big event — there are more photos of this than any other event at the dam. It must have been nerve-racking, with the first heavy truss suspended by a wire.

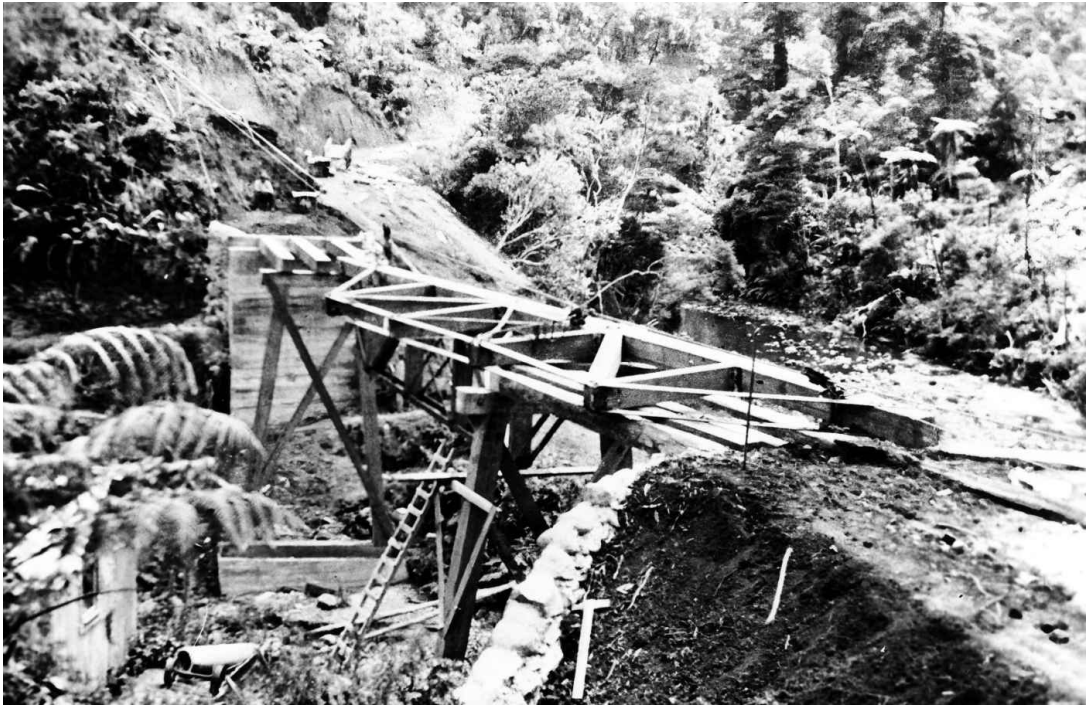
↑ Building Georges Bridge. Early 1926. One truss is in place and the second is being slid across.

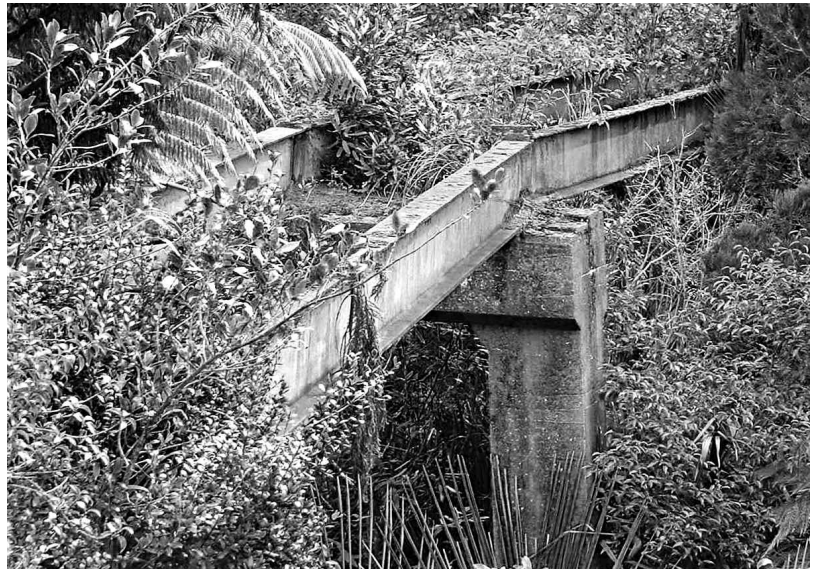
A bridge pier, 2004.

Lincoln Bridge had reinforced concrete piers. All other tramline bridges had piers that were simply bolted together flat on the ground and winched to vertical on their foundations. In contrast the Lincoln Bridge concrete piers were complicated to make. They needed temporary wooden forms to hold the concrete while it dried, temporary scaffolding to build the forms and a flying fox above the bridge to carry materials to the piers. Huia Bridge, which was the same size as Lincoln bridge, had simple steel piers. Though both bridges cost about the same: Lincoln 900 and Huia 850 pounds.

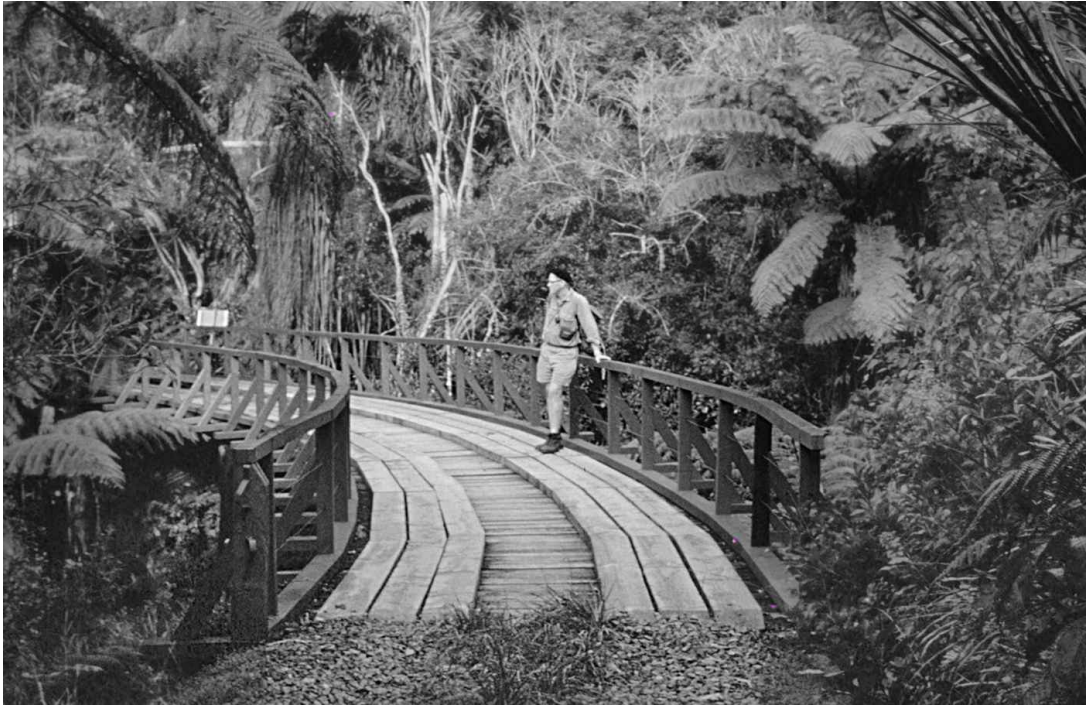
↑ Lincoln Bridge in 1962, after the tramline had been converted to a road.

In 1959 the tramline was lifted and became a road. In 1972 the bridge was abandoned because the abutments were cracking, and the road was deviated 30 metres further up the valley. Road vehicles can turn sharp corners, and the road has a small curve radius where it crosses the creek. No bridge is needed, just a pipe under the road. Lincoln Creek is now called Nugget Stream, after Nugget Thompson, a Huia dam caretaker from 1930 to 1953.

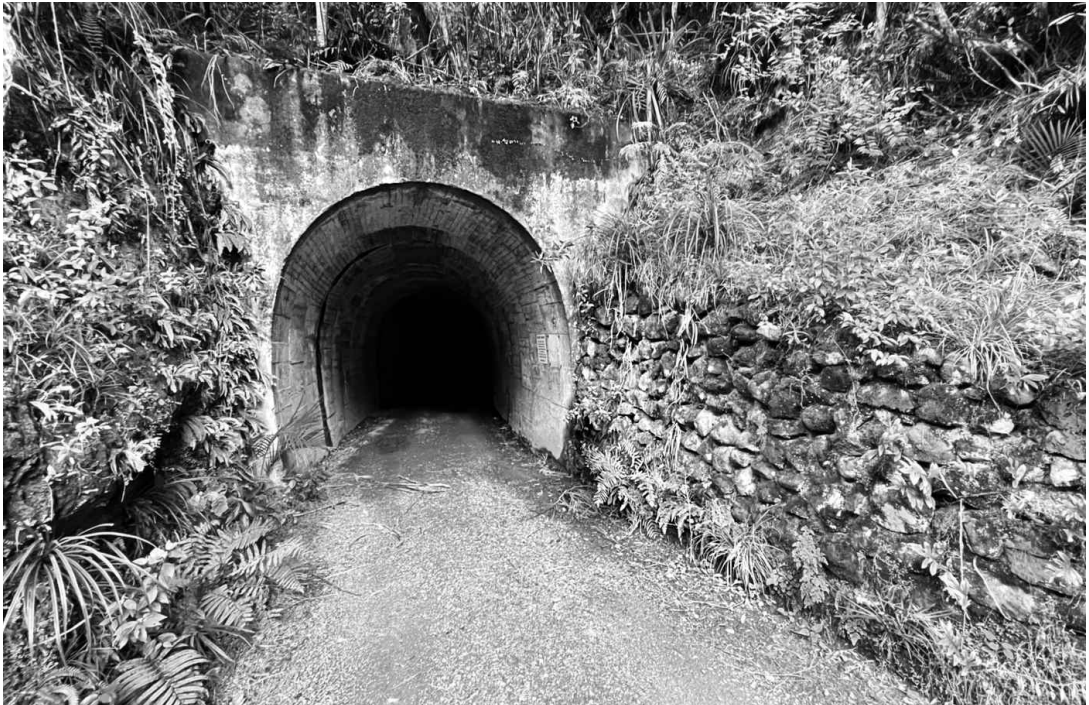
↓ The north end of the long tunnel, just up from Lincoln Bridge. This end originally had a timber roof to deflect falling rocks, but it was soon replaced with this concrete lining.

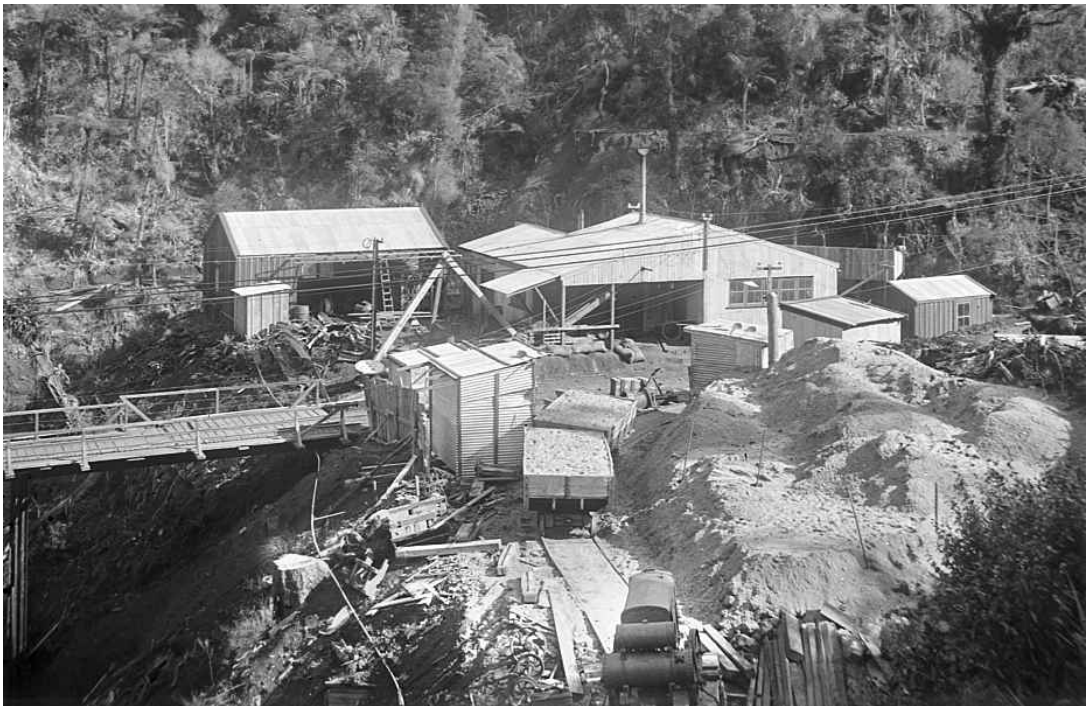
↑ Looking downstream to the dam. June 1928. The building is the crusher, with a wagon of sand beside it. The concrete mixer is under the crusher, to the left of and below the wagon.

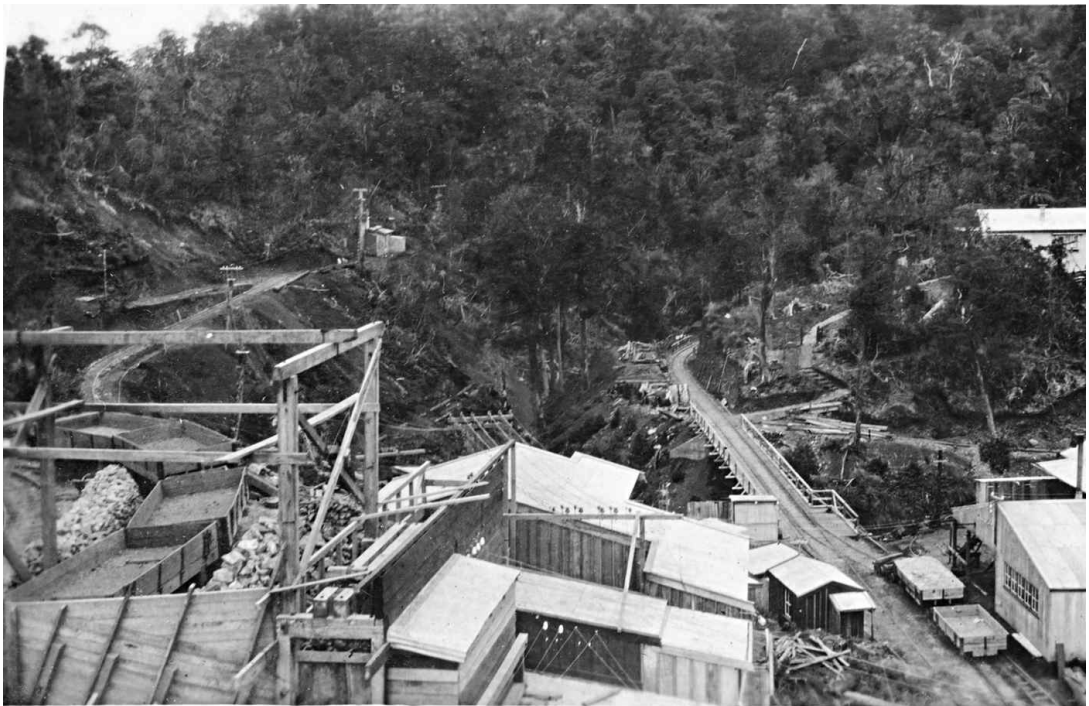
↓ Looking downstream from the dam. December 1928. From left: quarry tramline, rock crusher, landing tramline, workshops, stores and cottage. Back left is the switch line and engine shed.

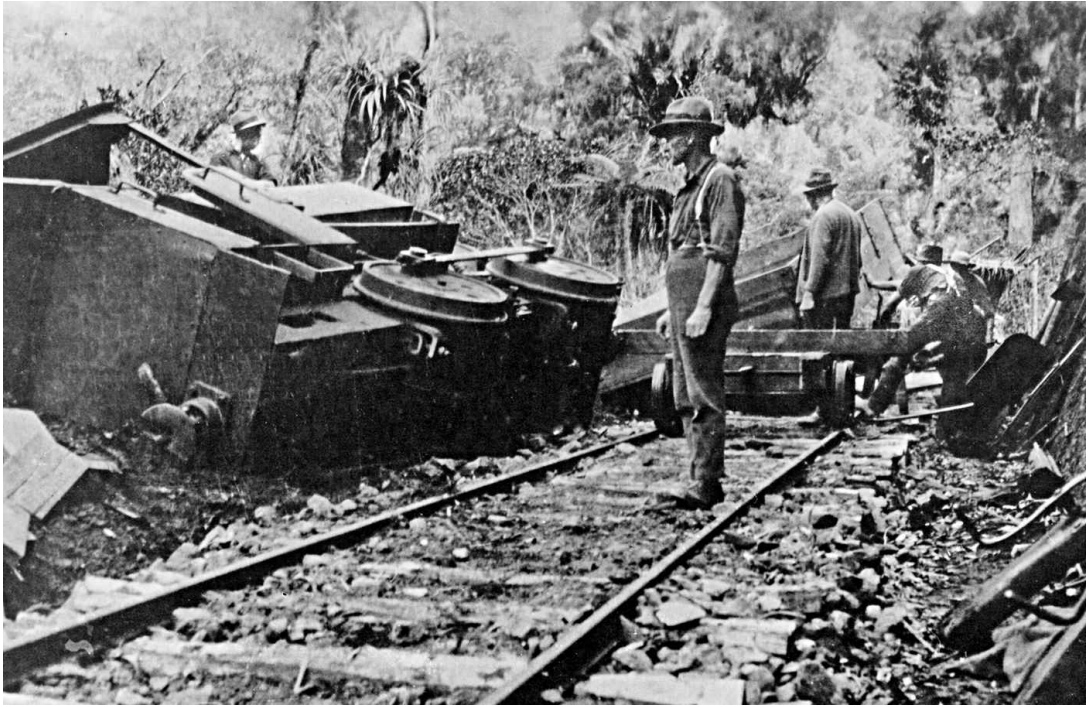
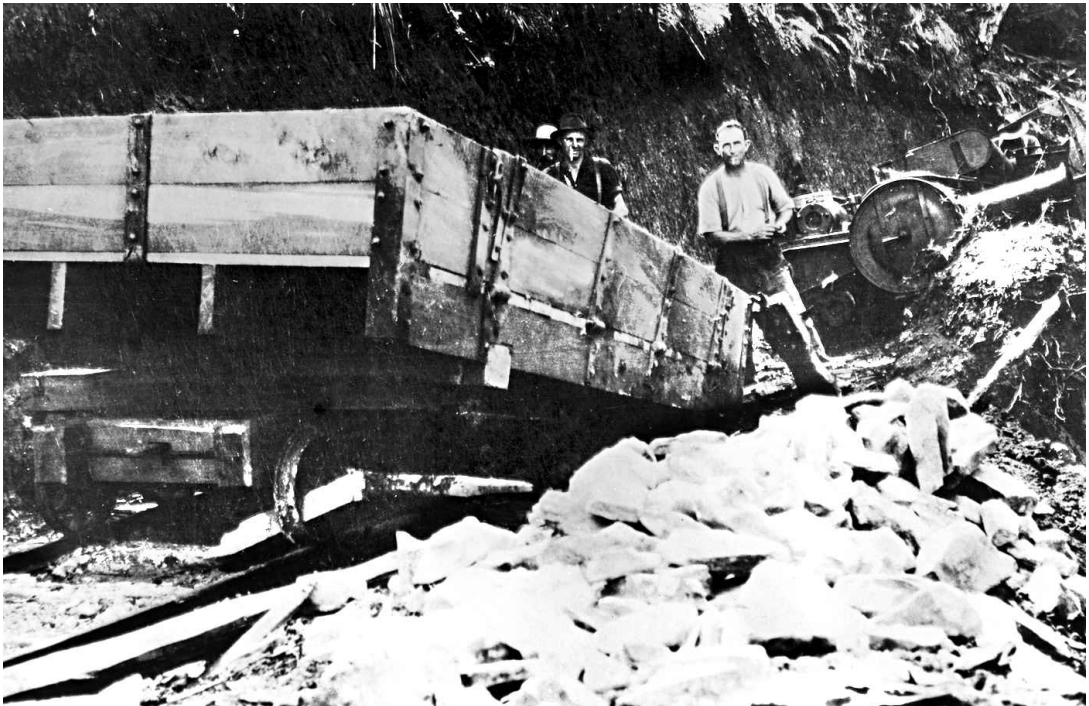
↑ A derailment on the quarry tramline. March 1928. ↓ Workers have unloaded the rocks from the wagon. 'There were some derailments in the first few weeks on the quarry line, until it settled into position, but on the whole, accidents were very few.' The man in the white shirt holds a timber jack, to push and lift the wagon into place.

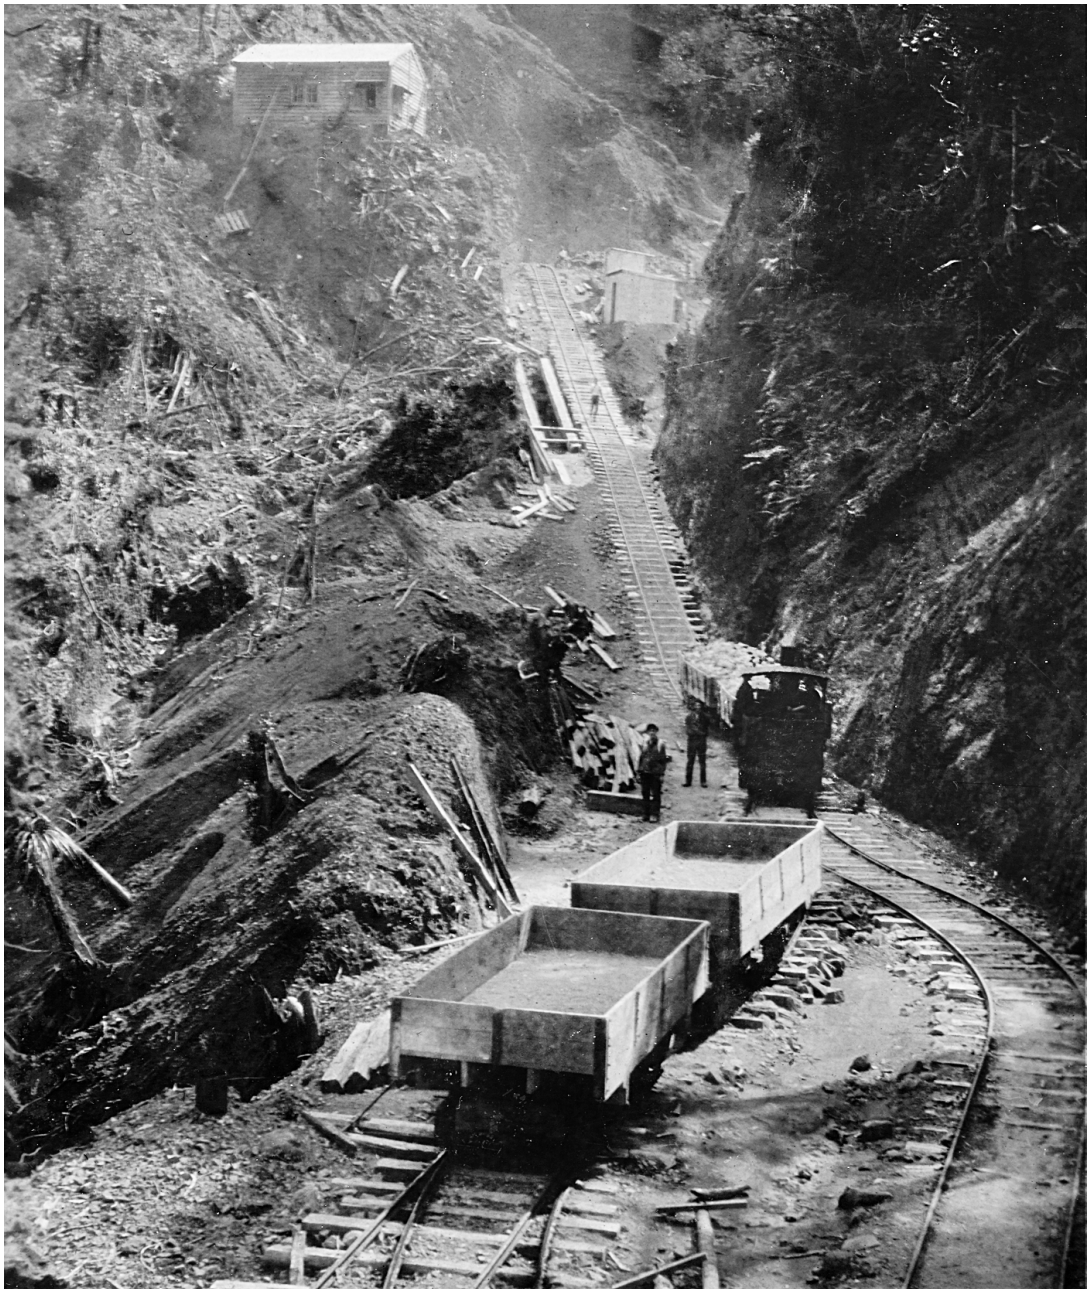
1 - Exchanging wagons at the incline, 1928

The last hundred metres of the tramline had to be steep to reach the quarry. Too steep for a locomotive. The engineers built an incline, and hauled wagons up and down with a winch. In the photo below, loaded wagons have been lowered down the incline to the locomotive and 3 empty wagons wait to be hauled up.

The incline was too steep for the locomotive to go up. At first, wagons were winched up and down. At the end of 1928, a second railway track was laid up the incline. Now, a full wagon going down pulled an empty one up.

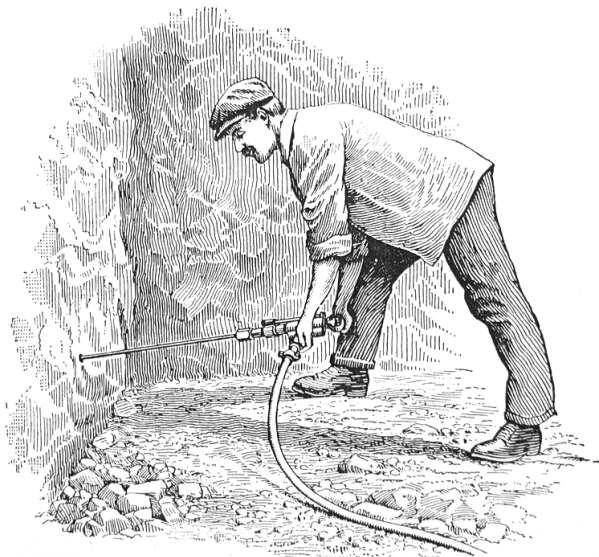
A popper drill. The drills at Huia were bigger. But where is the noise, the dust and the danger?

There could not be more than 3 feet of drill shaft out of the hole being drilled, or the shaft would bend. To avoid this, the driller screwed on combinations of 3-foot and 6-foot extensions as they drilled the hole deeper.

The drill bit was a steel rod, about 3 feet long. The cutting end was formed into a chisel shape or an X shape. In the drill, compressed air drove a hammer to strike the other end of the drill bit about 500 blows a minute. Pop pop pop ... When the hammer struck the bit it rotated the bit slightly, to make a round hole. The compressed air exhausted through a hole along the drill bit to blow stone chips out of the hole.

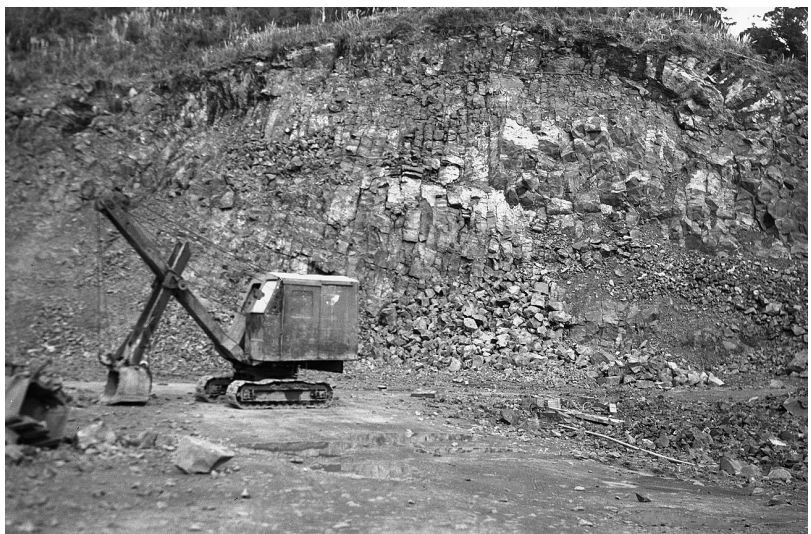
Te Henga quarry, also in the Waitākere ranges near Auckland. The quarry face is cracked into vertical columns, like at the Huia quarry. The pile of rocks at the bottom of the face has just been blasted.

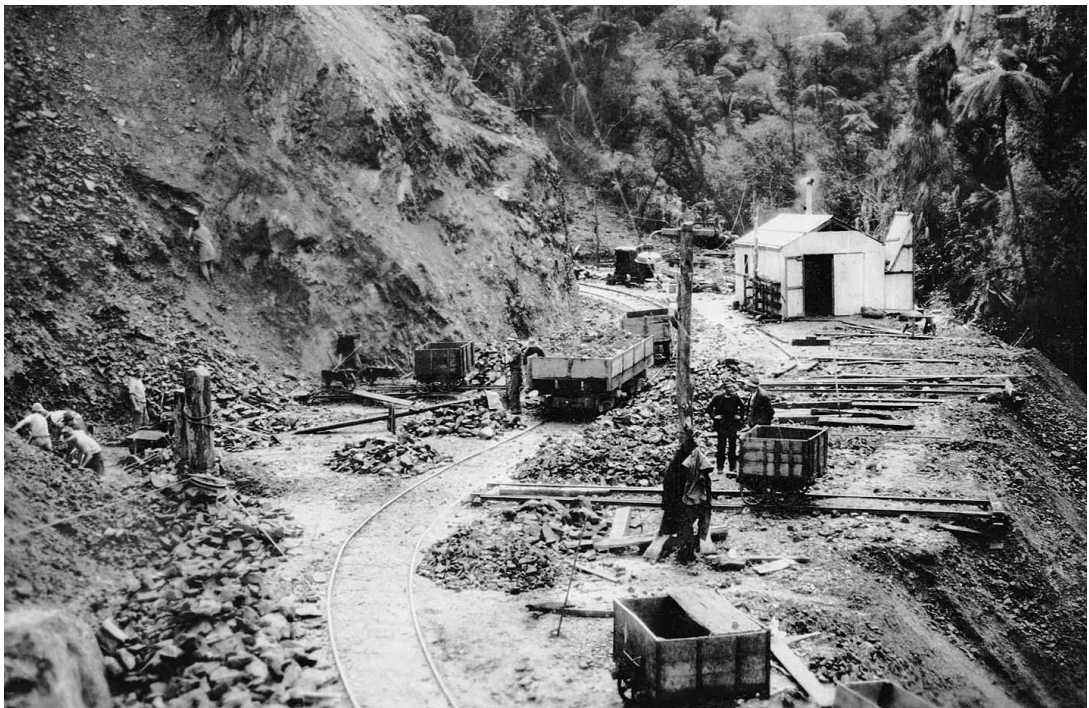
↓ Workers loading rocks on the floor of number 1 face. September 1928. The building is the blacksmith. Bottom left is the pulley for the incline.

The quarry workers moved material in wheelbarrows or in small wagons running on temporary railway track and pushed by hand. Workers picked out the usable rocks, probably using forks with widely spaced tines to pick up the the bigger rocks that they wanted. They moved them to the tramline to load into tramline wagons to go to the dam, or to stack beside the tramline to load later. They loaded the smaller reject rocks and other waste into other small wagons and dumped them into the nearby stream. This is on the right of the photo below.

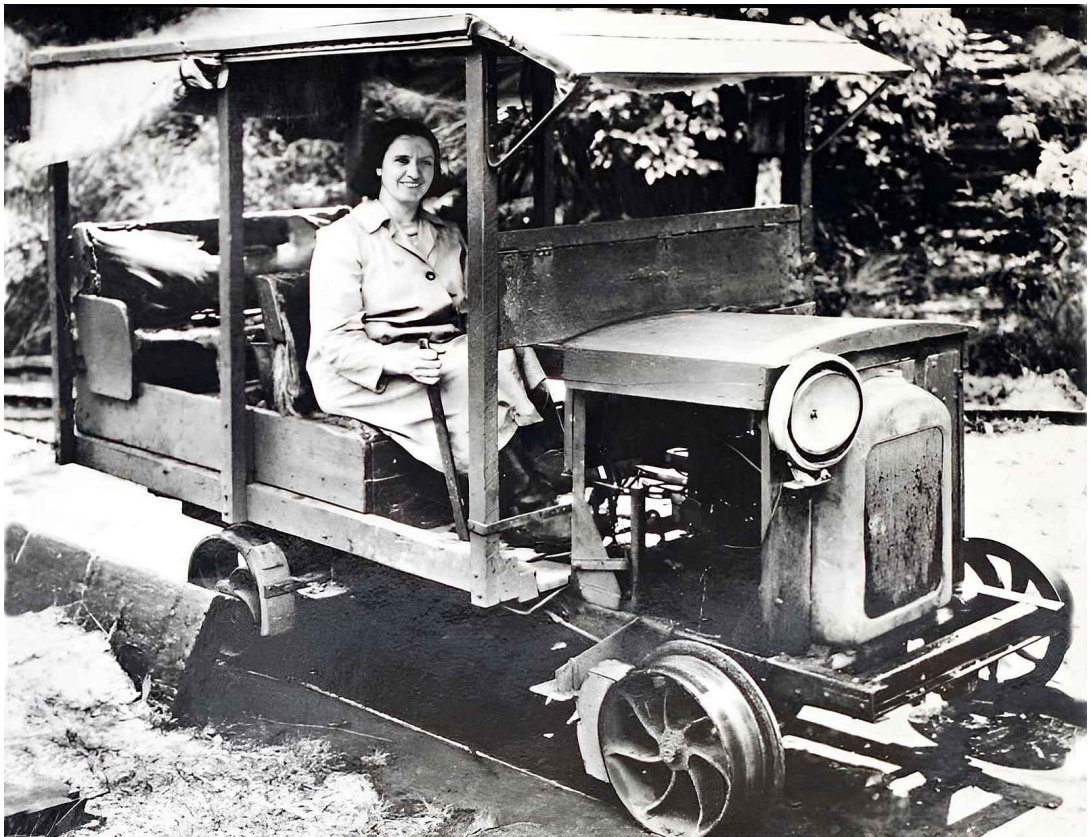
↓ Elvie Thompson in the caretaker's first jigger. About 1950.

Jiggers were like cars. Their gearbox had several forward and one reverse gear. The driver had to sit on a seat to operate the accelerator and clutch, and they faced forwards. Like a car, a jigger was hard to drive backwards for any distance. The tramline had turntables to turn the jiggers, so they could go forwards. There was a turntable just down from the jigger shed at Huia, at Smiths Creek, and at other places where there was railway track from the tramline down to Huia Stream to gather stones to crush. Most people I talked to agreed that there was no turntable at the dam. Some said that there was. All agreed that jiggers from the dam came down front-first.

A turntable was a steel plate 2.4 metres diameter, level with the ground. They would push on the jigger to turn it. Jiggers were sized to fit on a turntable.

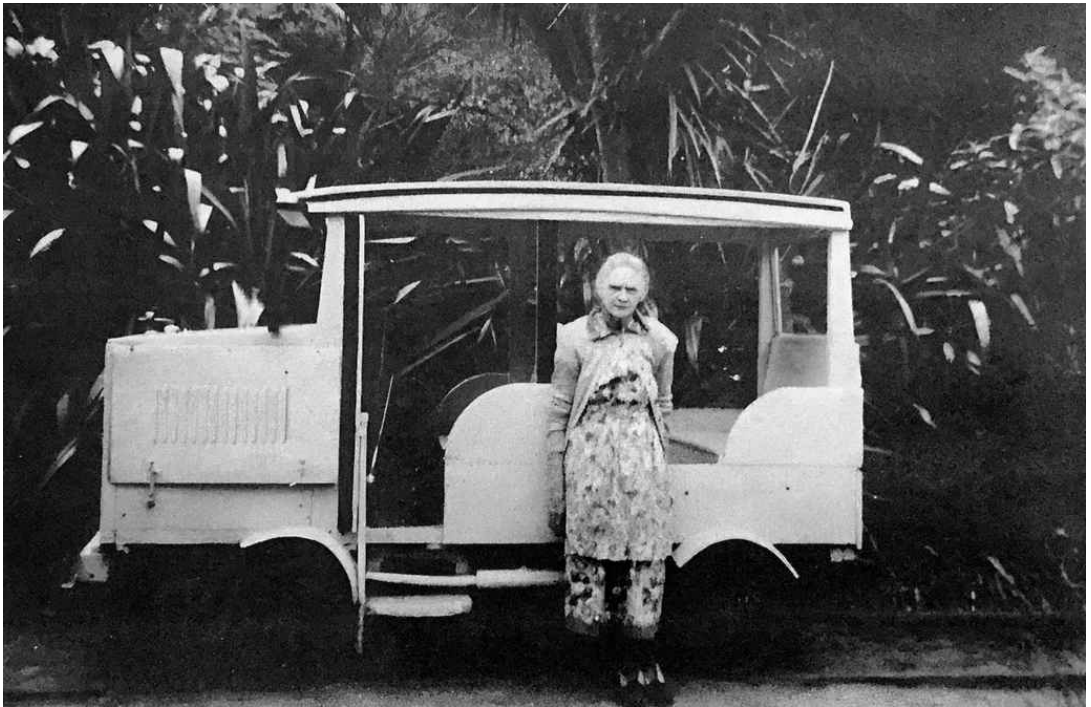
↓ I assume this is Elvie Thompson's mother, with the caretaker's second jigger. The jigger ended its days as a chicken coop at Lower Nihotupu Dam.

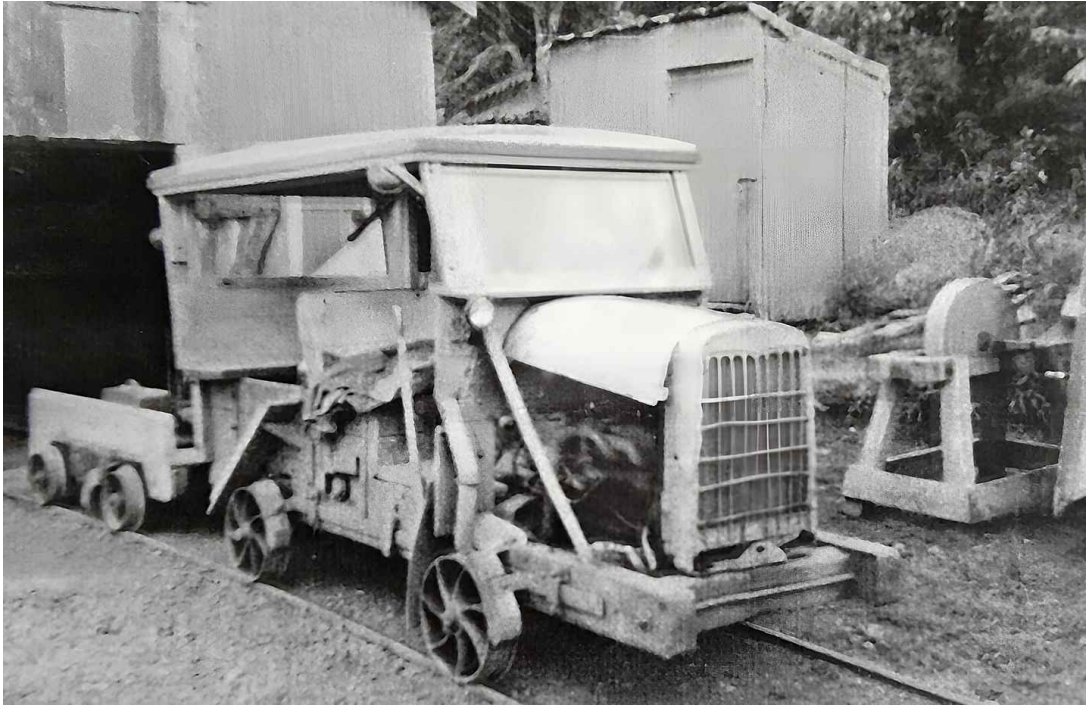
↑ The big jigger at the jigger shed. The wagon is a flat top with sides.

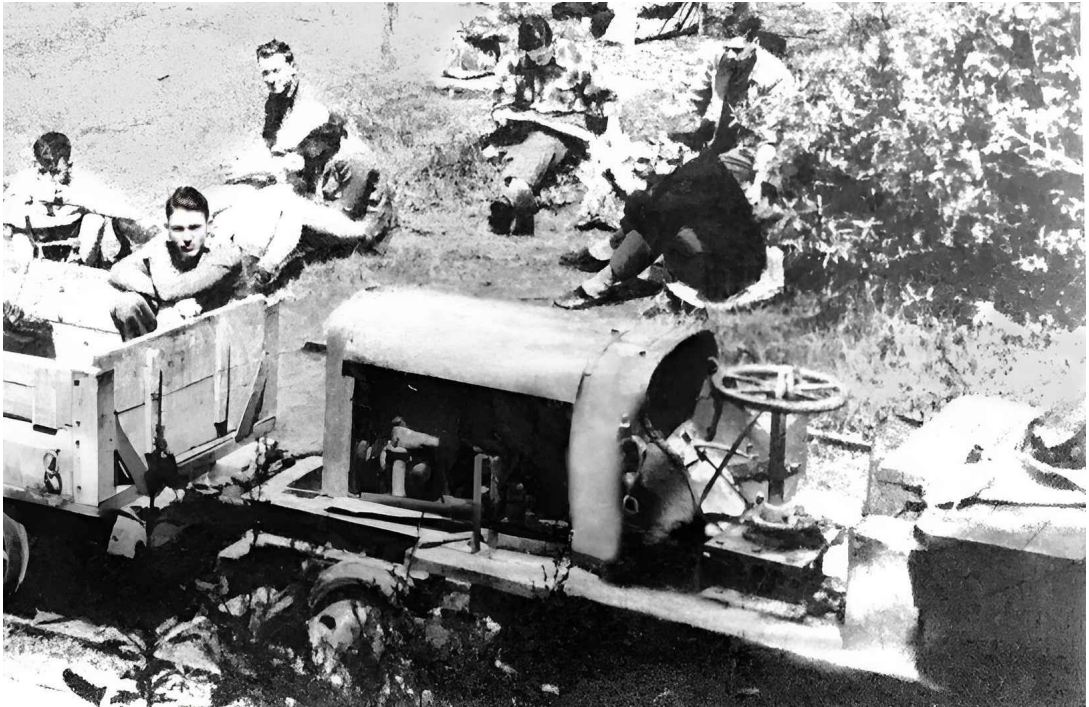
↓ The light jigger at the shed at the dam, with a party of enthusiasts. The wagon is a metal wagon.

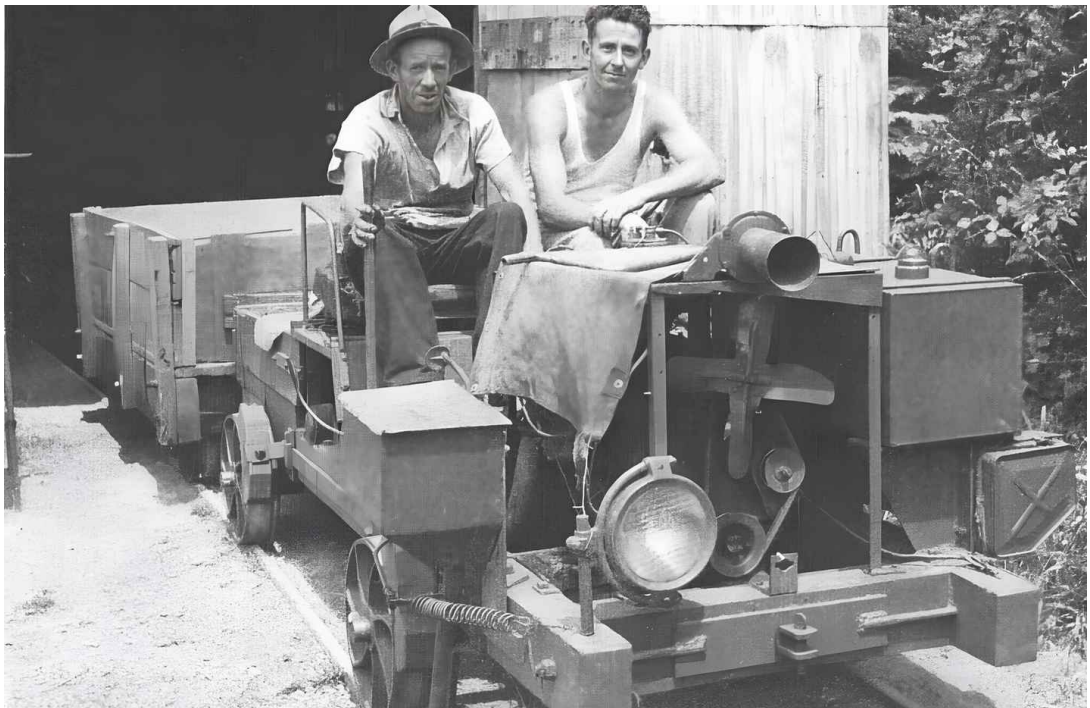
↓ A substantial jigger, pulling a metal wagon. At the jigger shed.

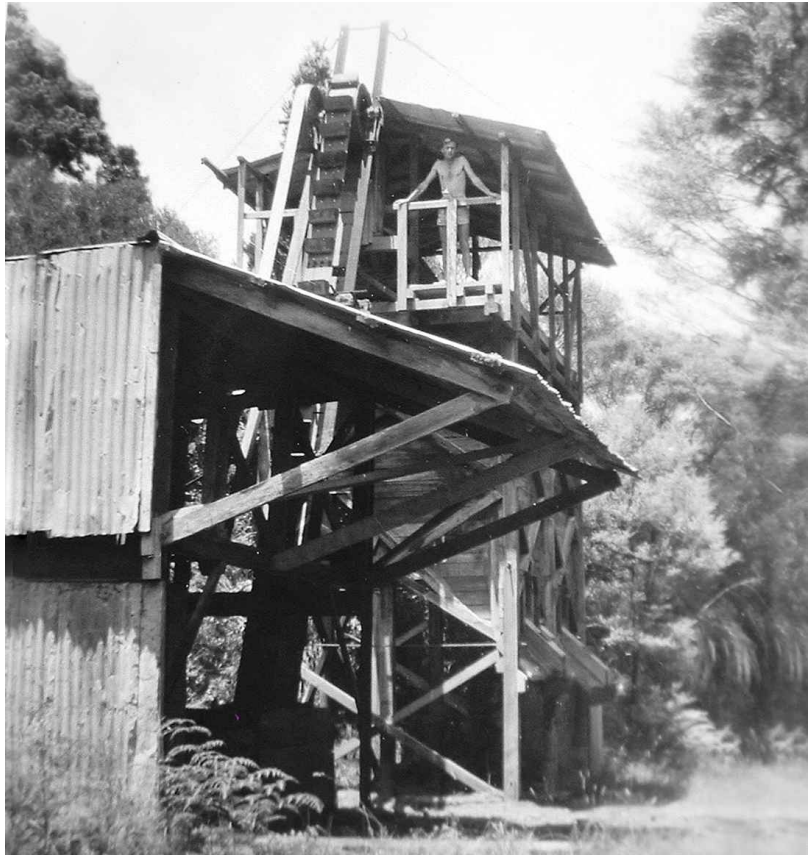
The middle crusher.
 The Pelton wheel
 and crusher are un-
 der cover on the left.

They used most of the bigger crushed stone to replace ballast lost by the vibration of passing trains or washed away by rain. They would load a wagon with crushed stone at the middle crusher, take it to the job, pull an end board off the wagon, shovel the stone off, and pack it under the sleepers with a sledge hammer.

When the tramline was lifted and converted into a road in 1959, the crusher crushed the stone for the road surface.
