The Huia Tramline

Peter Hopcroft

With its three feet six inch gauge, substantial ballasting, well-made cuttings and avoidance of erratic curves, the line is totally different from the usual run of tramlines found on large civil engineering tasks.

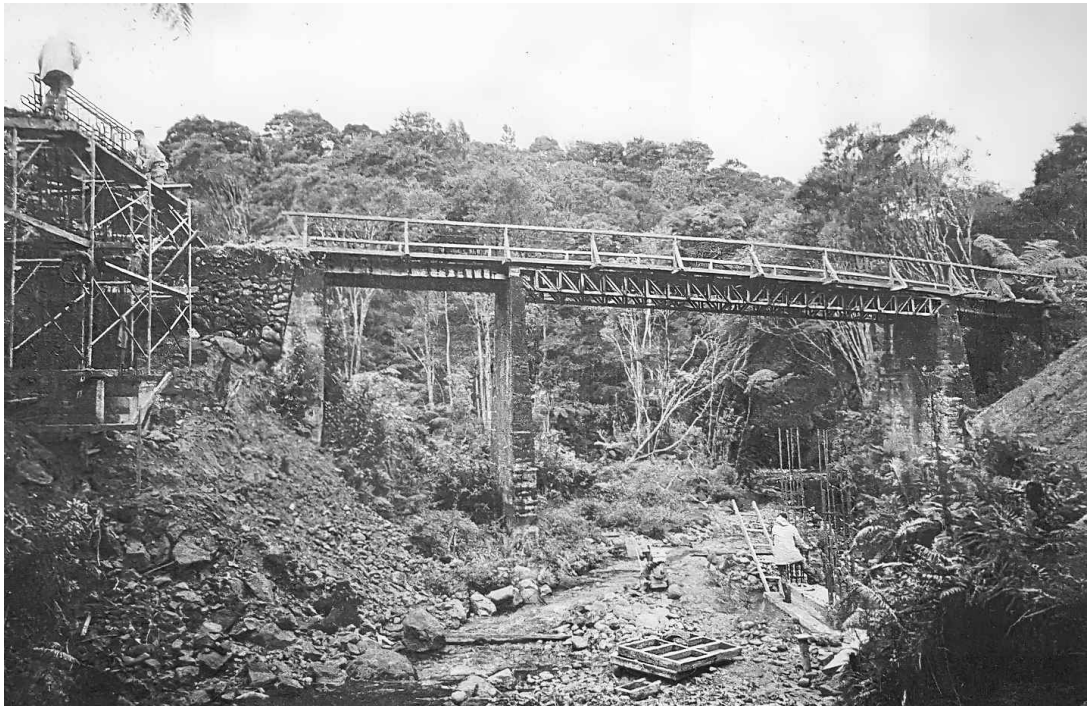
↓ The rebuilt Georges Creek bridge. About 1970. Looking down Georges Creek. Workers are starting to build the present concrete road bridge.

Took Moore remembered building the bridge. It was all done by hand. They pulled the old bridge down and built new concrete piers on the existing concrete pier foundations. There were shortages and they had no reinforcing steel.

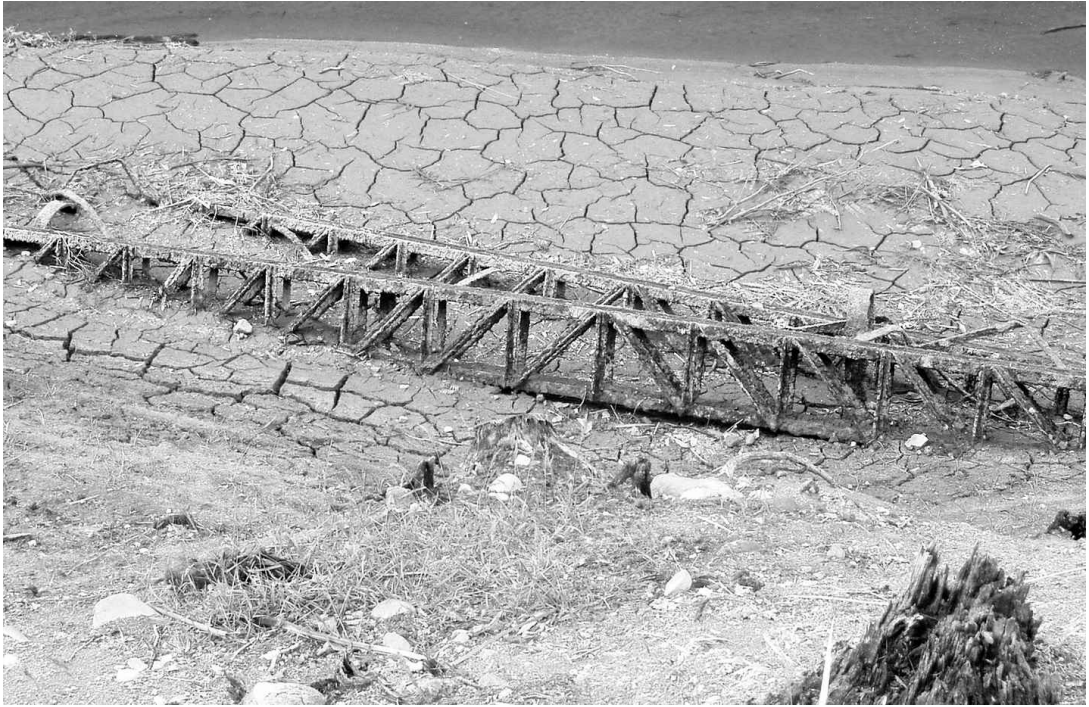
↑ In about 1970, the workers who built the present concrete bridge demolished the tramline bridge. They tossed the trusses down beside the stream. They are upside down now. ↓ The concrete piers, 2007.

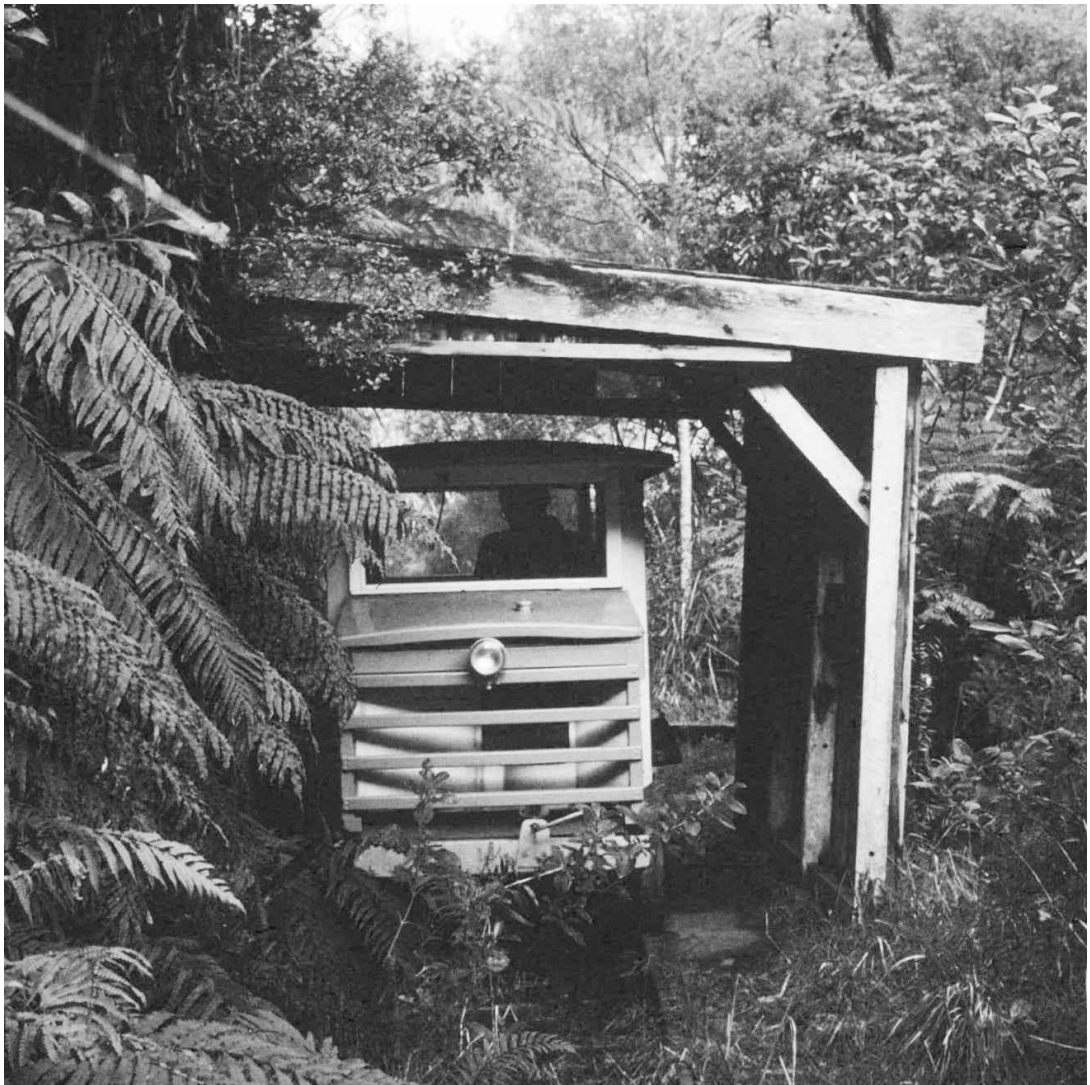
↓ The caretaker's second jigger, abandoned in its shelter at the dam. It's 1962, three years after the tramline rails were lifted.

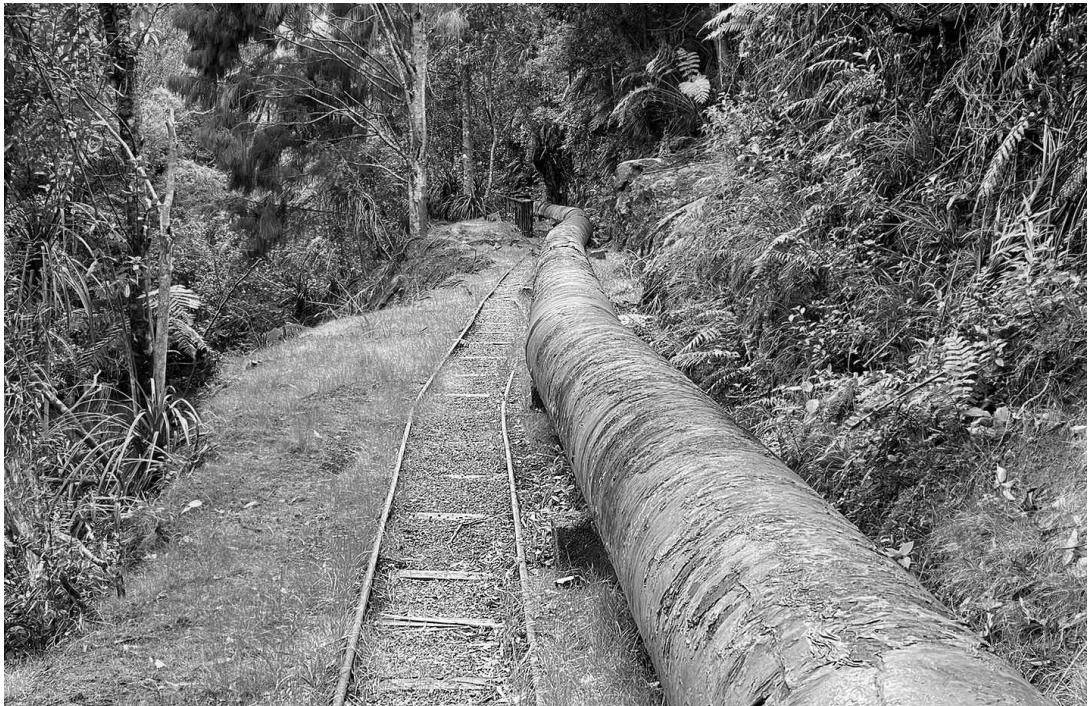
↑ From the south end of the tunnel, looking across pipe bridge number 1, over Huia Stream, to where the landing tramline ran. The concrete bridge piers and crossbeam are original. 2022.

The railway track was laid in the late 1920s to carry the pipes into place. Men or a horse would have pulled the wagons. Similar 2-foot gauge track was laid in the Nihotupu valley to carry pipes and supplies. This was one of the only sections of pipeline in the Huia valley that was not close to the tramline or a road, so the separate railway track was needed here.

The track's purpose now is to carry in new pipes if the pipeline bursts. In about 1970, the pipeline was upgraded with the pipes you see here. Harvey Stewart, who worked on this job, found the pipeline and track in poor condition. At the north end of the tunnel, it was covered by a slip. They cleared the slip and repaired the track. They laid the new pipes where the railway track was and then laid new track where the old pipe had been. So as not to interrupt the flow of water.
